**Hamilton West Pty Ltd**  
Dent Island  
Operational Environmental Management Plan

Version 1, 10 August 2017

Hamilton West Pty Ltd  
 Hamilton Island Golf Course Resort - Dent Island  
 ENVIRONMENTAL MANAGEMENT PLAN

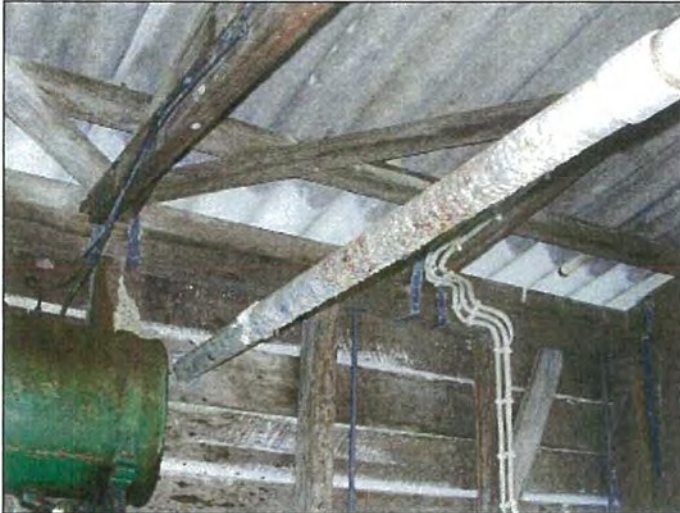
Photo S-7515: Winch House, remnant lagging on pipe

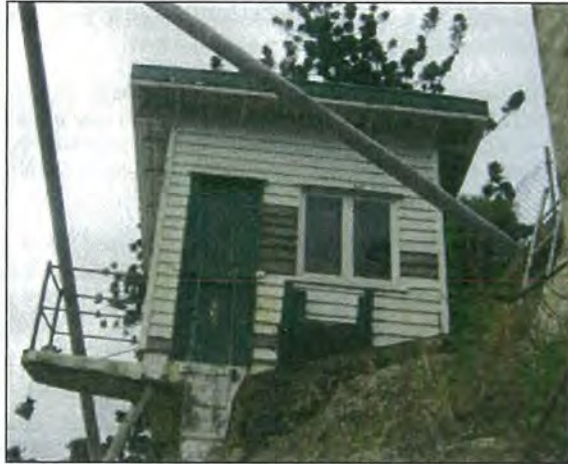
*Photograph 3: Winch house*

The external weather board nails were observed to be corroding throughout the winch house and these nails should be replaced and reinstalled as required using stainless steel grade 316 nails.

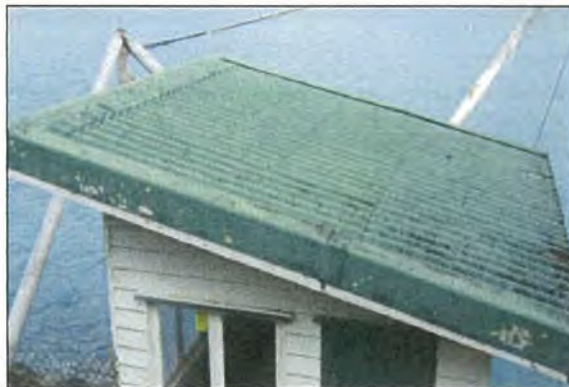
Photograph 4: Existing roof cladding

If it is deemed acceptable to remove the existing asbestos roof sheeting, new roof sheeting should be replaced with a new roof sheeting profile similar to the existing. New batten to rafter connections should be installed to meet design wind requirements and the roof sheeting should be fixed with cyclone clips at spacing to meet the wind load requirements for the location.

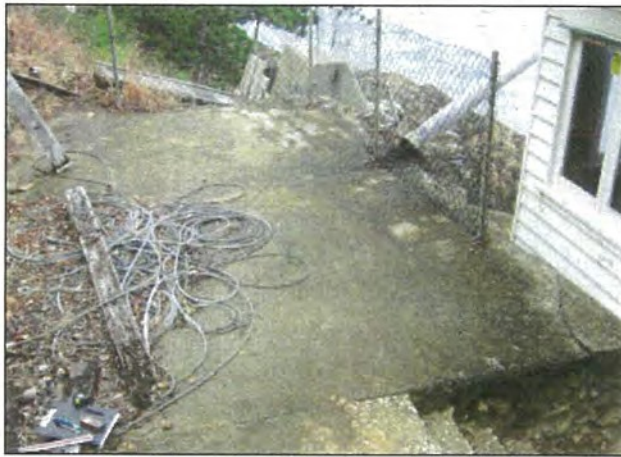
which is suspended should be barricaded until repairs have been completed. Significant corrosion of the reinforcement and spalling of the concrete to the underside of the suspended slab has occurred, which has resulted in the slab barely being able to carry its own weight. In one section of the suspended slab half of the slab thickness has completely delaminated in half as a result of extensive corrosion of the reinforcement steel within the slab.

*Photograph 5: Concrete platform to front of winch house*

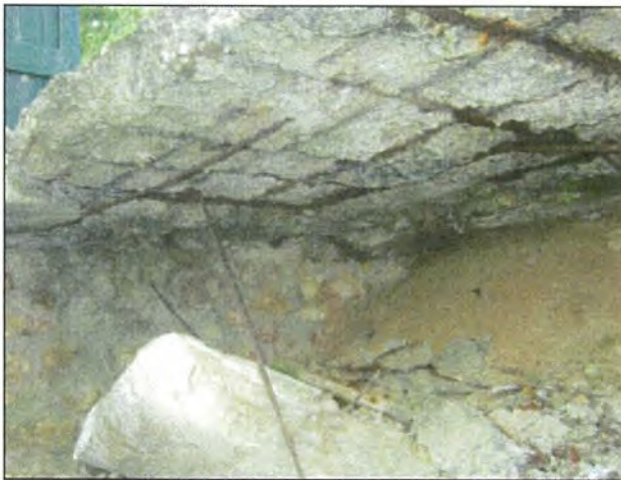
*Photograph 6: Extensive corrosion and delamination of concrete slab*

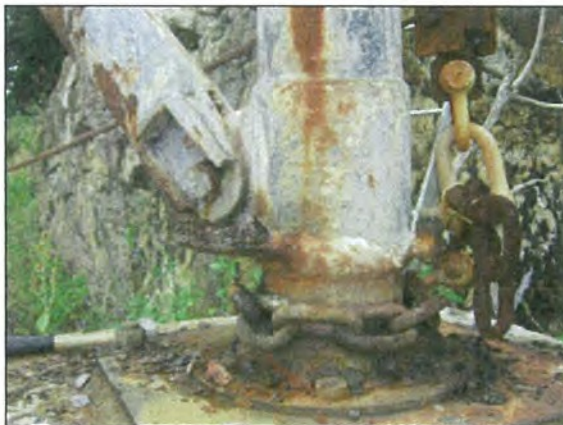
Significant corrosion is occurring at the strut connection locations as these areas are trapping moisture and contaminants. Although the central base connection has corrosion to the baseplate, bolts and connections, it is expected that no structural strengthening or welding will be required. It is instead proposed to fully remove the corrosion to a class SA 2.5 finish and reapply the protective coating system. For a marine grade paint specification, it is anticipated that life to first maintenance will be up to 15 years.

Photograph 8: Corrosion to central base connection

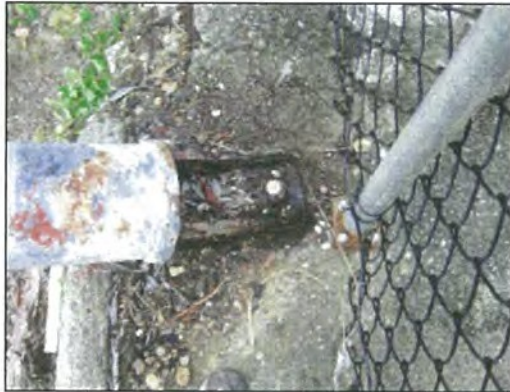
Extensive corrosion has occurred to the upper strut connections of the winch assembly. These connections will require structural strengthening and repairs to be completed. The level of corrosion to the upper connections is more extensive than at other locations along the winch assembly as the connection holds moisture and debris which accelerates to rate of corrosion. It is recommended as part of the ongoing maintenance of the winch assembly that the connections be regularly inspected with any dirt and rubbish being removed from around the connection as required.

*Photograph 9: Corrosion and debris around upper strut arm connection*

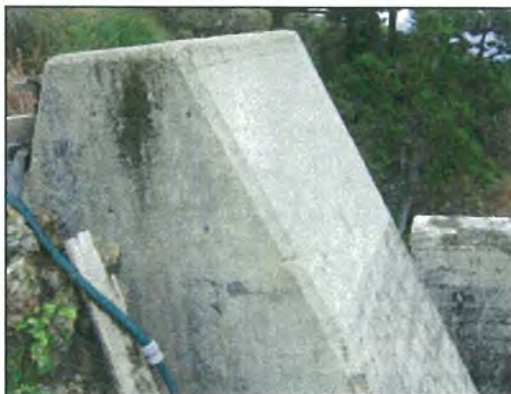
The concrete anchor blocks at the base of each of the three supporting strut arms were inspected and found to be in good crack free condition. No remediation or repair work is required to the concrete anchor blocks at this stage.

*Photograph 10: Concrete derrick crane anchor block*

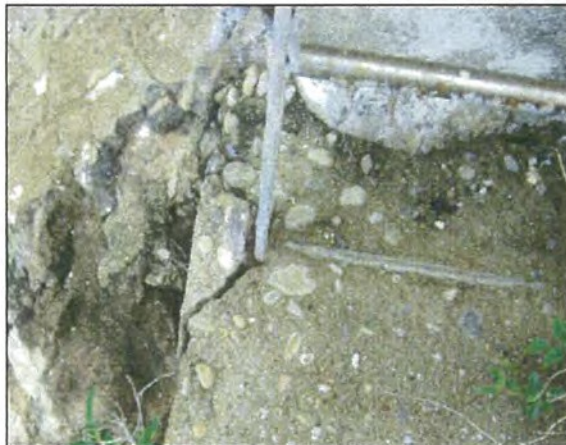
Concrete was observed to be spalling at the base of the steel access ladder to the winch house. The concrete and steel support at this location should be repaired locally to prevent further spalling and stop the current corrosion that is occurring.

*Photograph 11: Concrete spalling and corrosion of access ladder*

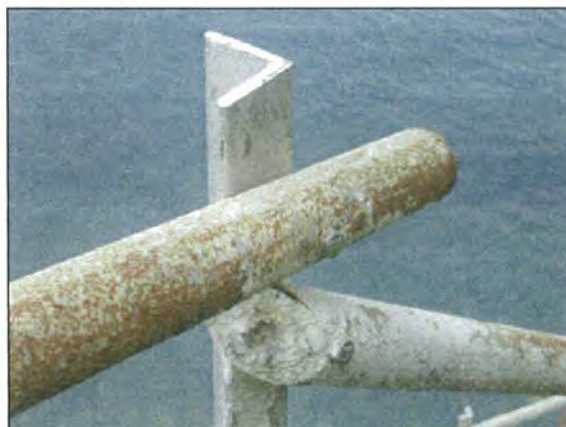
A number of the handrails to the perimeter of the site were observed to be connected using dissimilar metals. These connections involved galvanised and mild steel tubes and angles in contact with stainless steel bolts. Locations where dissimilar metals are in contact with each other will result in accelerated corrosion. The metals should be fully isolated using neoprene washers.

*Photograph 12: Handrail with dissimilar metals in contact*

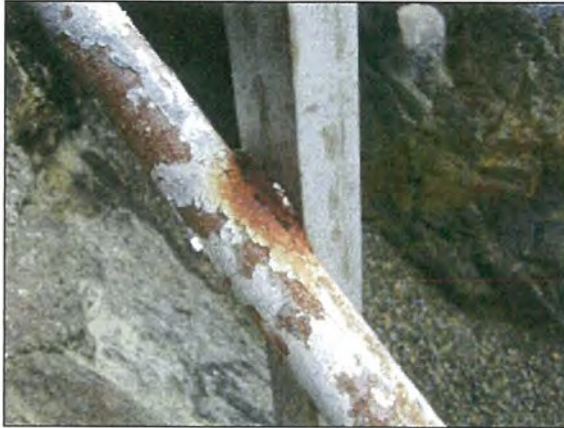
*Photograph 13: Handrail with dissimilar metals in contact*

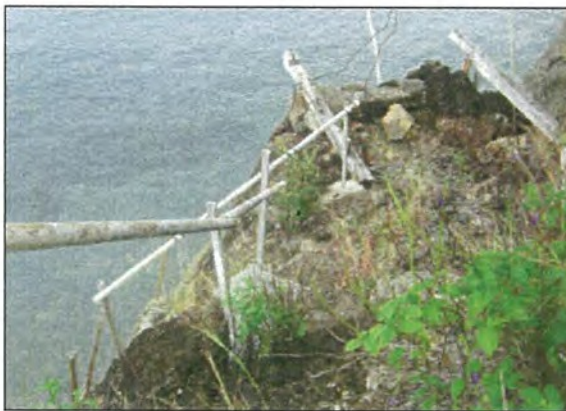
A number of the handrail sections down to the water level were not continuous and may not comply with the requirements of the Australian Standards. It is recommended that further clarification be sought as to whether the handrails need to be compliant to any regulations or standards.

*Photograph 14: Access handrail down to water*

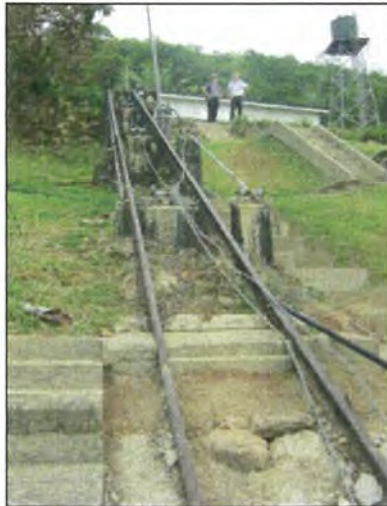
Photograph 15: Winch trolley rails and supports

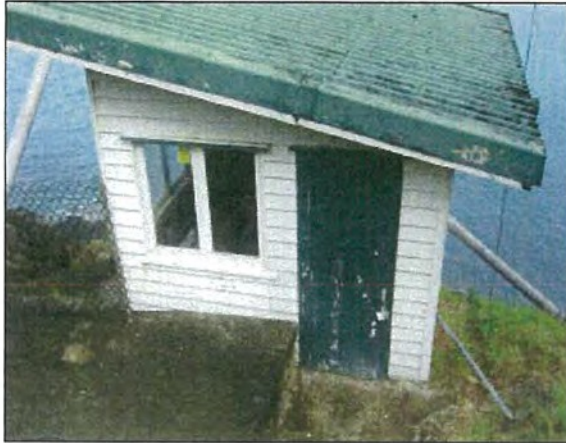
*Photograph 16: Winch house to be painted*

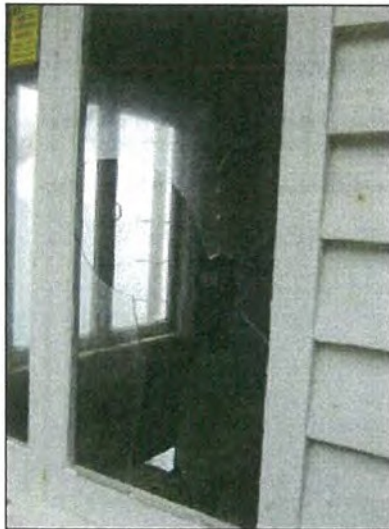
*Photograph 17: Broken window to be repaired*

2. Repair and replace broken window.

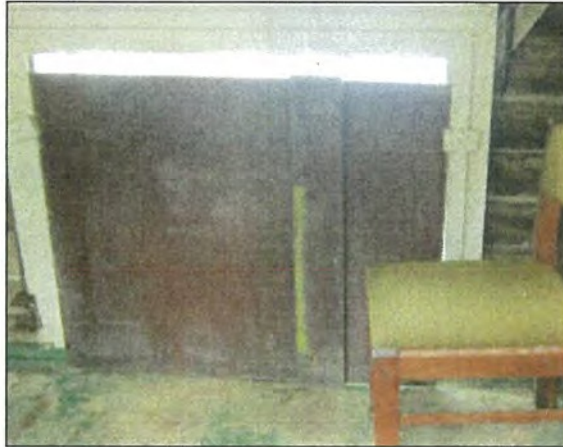
**Photograph 18:** Plywood infill panel to be replaced

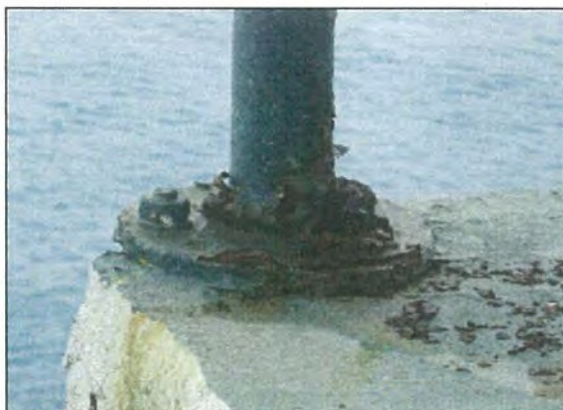
**Photograph 19:** Baseplate repair

4. Repair corroded baseplate of two external handrail posts.
  - Cut existing baseplate off.
  - Re-weld new cap-end base plate and install two new grade 316 stainless steel chemical anchors into existing.
  - Stainless steel bolt to be fully isolated from mild steel using neoprene washers.
  - Refer to Appendix A for structural sketch details.
  - Reinstate protective coating to handrails to match external steel paint system.

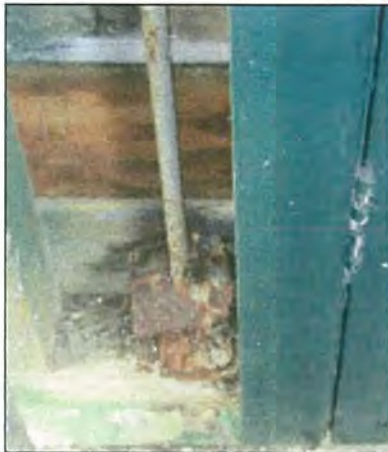
Photograph 20: Typical corroded base tie-down connection

- Allow to repaint six existing tie-down rods.

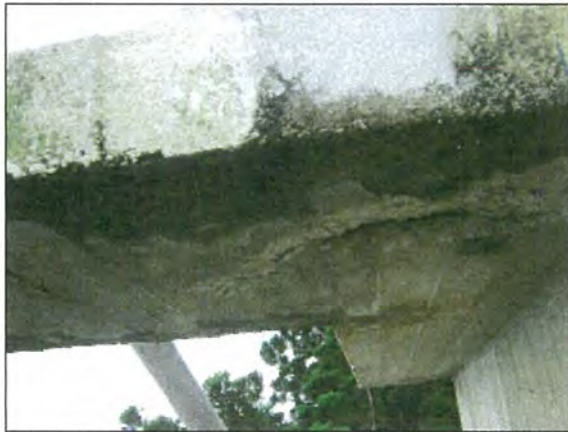
*Photograph 21: Spalled concrete to underside of viewing platform*

- Apply Sika MonoTop – 620 as required for final fairing coat and finishing.
- Concrete repairs to be completed by competent concrete remediation specialists strictly in accordance with manufactures requirements.
- Install a new drip groove to the edge of the cantilevered slab. Drip groove can be installed as a 25mm x 25mm stainless steel angle in required.
- Install new strut as detailed. Refer to Appendix A.

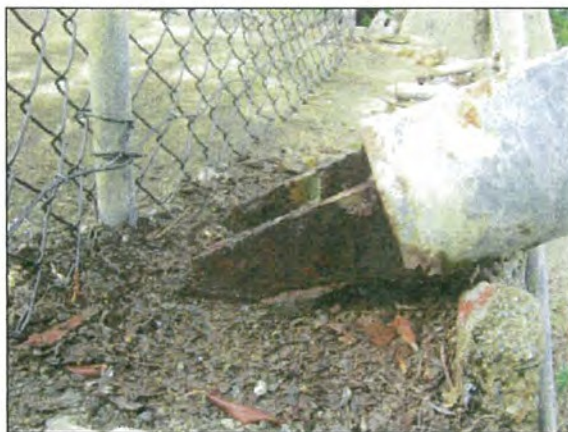
*Photograph 22: Corroded base connection of strut to be repaired*

8. Install structural base connection repair to upper two winch arm struts.
- Refer to Appendix A for structural repair sketch details.

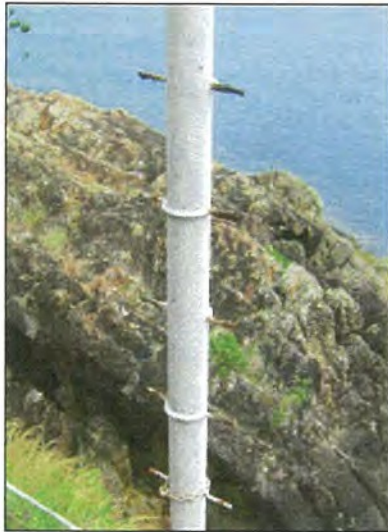
Photograph 23: Replace existing climbing rungs to central winch arm

- Cut off existing rungs at face and weld identical bar size to face using full strength butt weld (13 No. climbing rungs in total).
- Refer to Appendix A for repair sketch details.

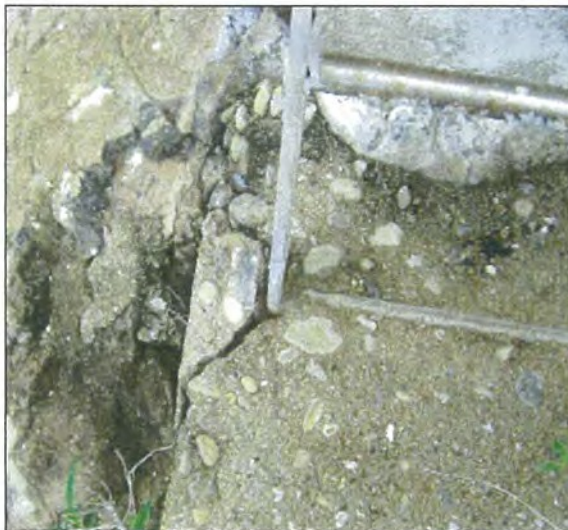
*Photograph 24:* Local concrete spalling at ladder support leg

- Removed spalled concrete.
- Fully remove corrosion from base of ladder leg.
- Paint ladder to steel specification.
- Repair concrete locally using Sika MonoTop-615HB.

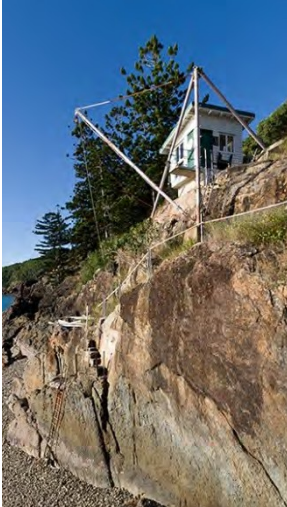
| <i>Element</i> | <i>History</i> | <i>Description and condition</i> | <i>Significance</i> |
|---|---|---|---|
| | <p>Built in the late 1950s. In service until the light-station was de-manned in 1987.</p> | <p>Timber-framed, skillion roofed, single room building on suspended reinforced concrete slab floor. Roof sheeted with <i>Super Six</i> asbestos-cement, with matching accessory barge pieces. Walls sheeted with hardwood weather-boards.</p> | <p>Moderately significant for these reasons:</p> <p>The winch house and its equipment demonstrates the development and operation of the light-station, particularly the work of transferring fuel, equipment and stores from boats (criterion a).</p> |
| | | <p>Timber casement windows, and solid timber doors and hatches.</p> <p>Inside the building is a reel winch driven by a small diesel engine, set up to control both the lifting line on the crane, and the trolley hauling line.</p> <p>The building is in a deteriorated condition.</p> | <p>The winch house and its associated components are typical elements of lightstations on elevated sites serviced from the sea (criterion d).</p> |

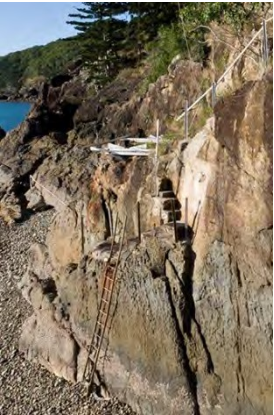
| <i>Element</i> | <i>History</i> | <i>Description and condition</i> | <i>Significance</i> |
|---|---|--|--|
| <p><b>6 Boat platform and access ladder</b></p> | <p>Built in the late 1950s. In service until the lightstation was demanned in 1987.</p> | <p>Steel and timber cradle to support a small boat midway between the sea and the landing platform.</p> <p>The platform and ladder are in a deteriorated condition.</p> | <p>Moderately significant for these reasons:</p> <p>The boat platform and ladder demonstrate the development and operation of the lightstation, particularly the work of handling small boats that were part of the equipment of lightstations (criterion a).</p> <p>The boat platform and ladder are typical elements of lightstations on elevated sites serviced from the sea (criterion d).</p> |

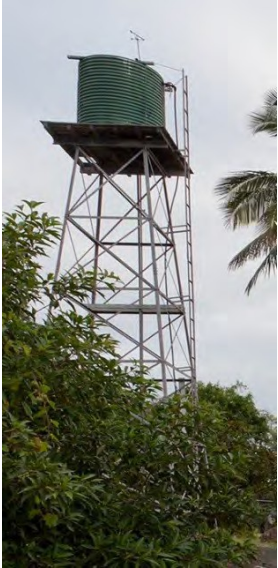
| Element | History | Description and condition | Significance |
|---|---|--|--|
| <p><b>13 Metal water tank and stand</b></p> | <p>Built around 1960 as a header tank to supply rain-water pumped up from the concrete tank.</p> <p>No longer in service.</p> | <p>Standard type galvanized steel lattice tank stand, supporting a corrugated steel tank.</p> <p>The stability of the structure has not been assessed.</p> | <p>Moderately significant for these reasons:</p> <p>The tank demonstrates the development of the lightstation, particularly the improvements to the keepers' living conditions made in the 1950s (criterion a).</p> |
